# FiberGuide outperforms competitor in controlled test

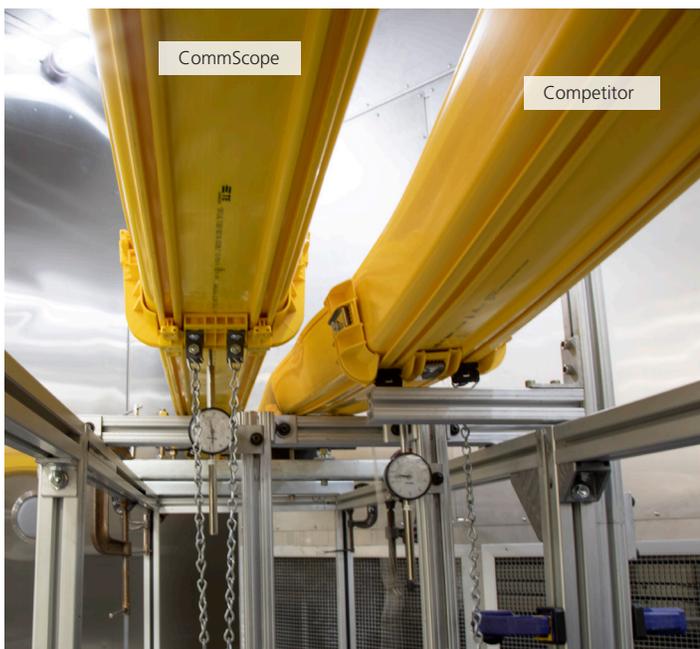
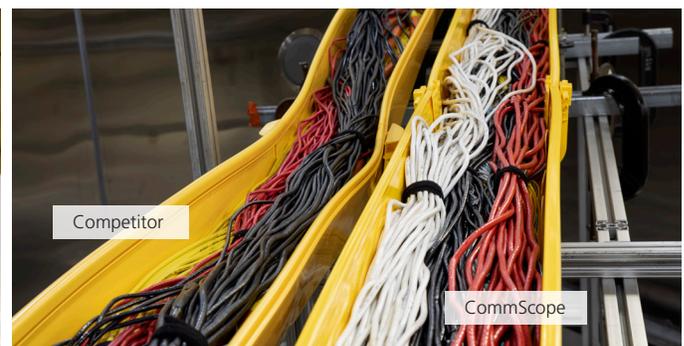
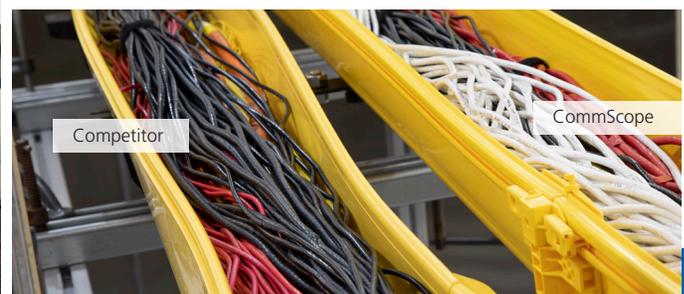
FiberGuide® passed the engineering specification for the entire duration of the test—120 hours—with .87" (2.21 cm) deflection.

The competitor's system failed within the first hour, with a deflection greater than 1.25" (3.18 cm).

With the external load removed and cable load still in place, the sample continued to sag until bottoming out at a secondary stop. Permanent deformation was extreme.

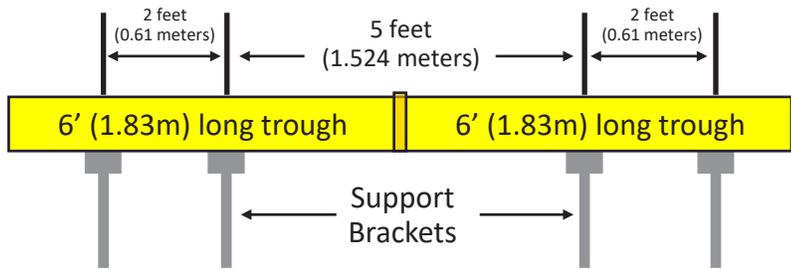
Figure 1.

The test setup, shown in Figure 1, is the one used in the testing facility's environmental chamber for the FiberGuide system. This setup was modified to decrease the span between supports from six feet to five feet, per the competitor's specification.

The samples provided by both vendors had to be based on processes and tooling used to manufacture products for sale.

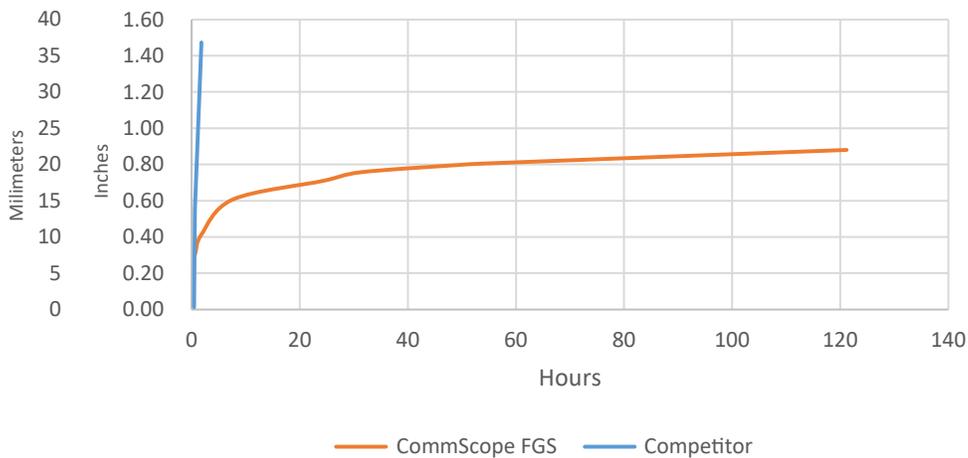
Figure 2.

Figure 2 shows the extreme and permanent deformation of the competitive system over time.

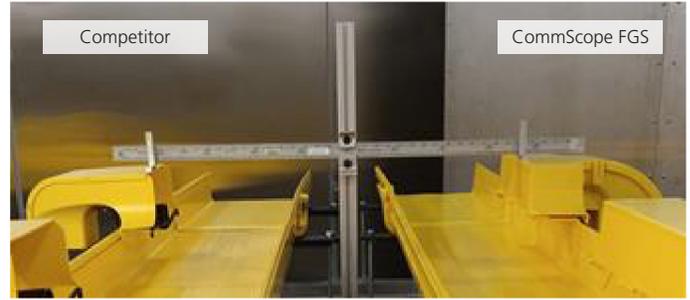
Figure 4. Initial

Test started at 60°C and was checked every hour for sample deforms for 3 hours at each temperature up to 70°C.

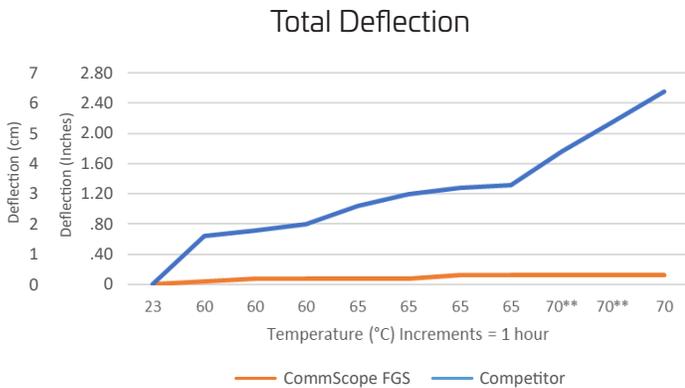
Figure 3. Test Results - Deflection vs Time and Temperature

\*\* No measurements taken at these time increments. 70°C measurements were performed post-test at room temperature.

Sample	Deformation Temperature	Observations
CommScope	>70°C	0.12" (0.3 cm) change in deflection measurement over 10 hours of 60°C to 70°C
Competitor	55°C–60°C	2.52" (6.4 cm) change in deflection measurement over 10 hours of 60°C to 70°C

**FiberGuide® passed** the engineering specification for the entire duration of the test – 10 hours – with .12" (.30 cm) deflection.

**The competitor's system failed** with a deflection of 2.52" (6.4cm).
